URGENT MEDICAL DEVICE CORRECTION

Medfusion™ 3500 and 4000 Syringe Infusion Pumps

April 19, 2022:

Medical Device Correction Notice: Medfusion 3500 and 4000 Syringe Infusion Pumps
Smiths Medical Ref: 3012307300-03/28/2022-002-C

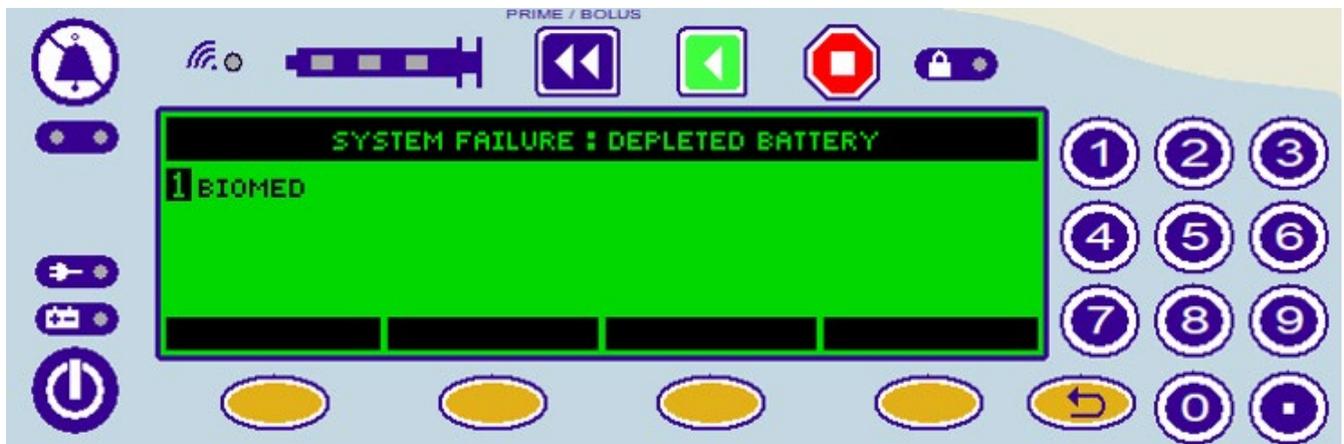
Under certain conditions with excessive pump wireless network activity, the pump may enter a state where the smart battery cannot provide its status to the pump. For example, some network settings, including Transport Layer Security (TLS), may cause excessive network activity. Smiths Medical only supports TLS version 1.0 on the Medfusion 4000 pump. If a version

of TLS other than 1.0 is utilized, it may result in excessive network activity, leading to unanticipated depleted battery alarms.

If the pump is unplugged and running on battery, the pump assumes the battery is depleted and sounds an unexpected Depleted Battery (DB) alarm, as shown in the following figure (Figure 1), without the Primary Low Battery alarm being triggered. Even if the battery contains sufficient charge capacity, any ongoing infusion will be interrupted.

Figure 1: System Failure: Depleted Battery Alarm

If the pump is running on battery power and a Battery Communication Timeout (BCT) alarm occurs, the pump assumes the battery is depleted and issues an unexpected Depleted Battery alarm. If the pump is infusing, interruption or delay of therapy may occur as a result. Depending on the patient's condition, the type of medication being delivered, the length of time the therapy is interrupted, and the level of clinical supervision, prolonged symptoms and a potentially life-threatening situation could occur. **To date, Smiths Medical has received reports of four serious injuries related to this issue.**

2. Unless your facility informs you that pump wireless communications are disabled, **be aware that unexpected Depleted Battery alarms may occur** when batteries should have sufficient charge capacity **and that these alarms will stop the infusion.**

3. Unless your facility informs you that they disabled pump wireless communications, **keep the pumps plugged into AC power whenever possible.**
 4. **If possible, do not use the pumps if they are disconnected from AC power.** If you must use the device on battery power, for example, when transporting a patient who has critical medications infusing, **bring backup pumps** to use in case this issue occurs. **Be aware that this issue may occur on backup pumps as well.** Plug the pumps back into AC power as soon as possible.

5. If this issue occurs while a pump is on battery power:
 - Press the Power button to turn the pump off.
 - Plug in the AC power cord, and turn the pump on. You can resume the infusion from the point when the alarm interrupted the infusion by following these steps:

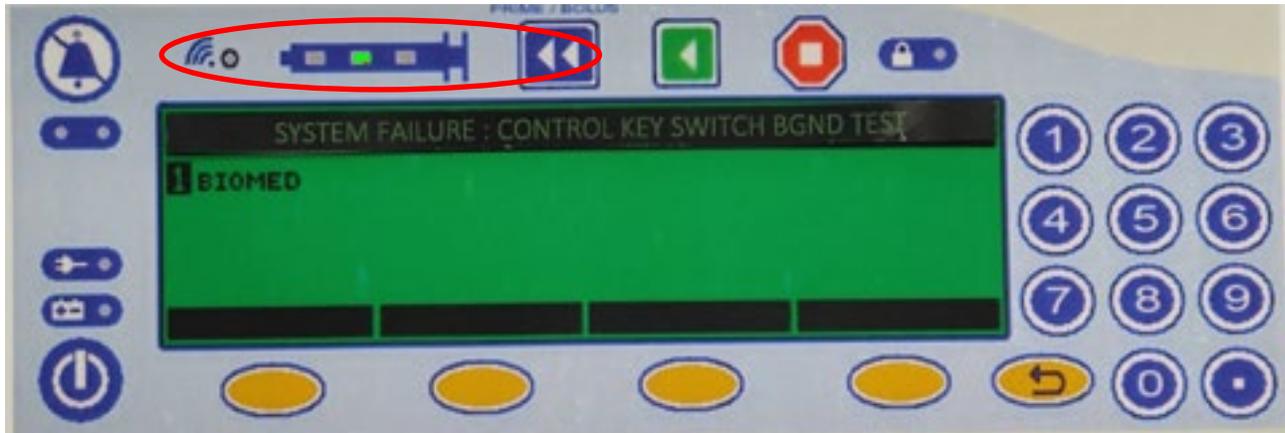
the pump is transitioning from IVOT delay to IVOT delivery, the pump may continue to run without the ability to terminate infusion via the Stop or Power keys. In the following figure (Figure 2), the green light indicates infusion is ongoing even though the pump displays a System Failure alarm.

Figure 2: Green light indicates IVOT Infusion Continues after System Failure

Failure of the pump to stop running in a System Failure condition could result in over-delivery of medication which could cause serious harm or death. **To date, Smiths Medical has received reports of one serious injury potentially related to this issue.**

1. **Do not use the IVOT delivery mode until this issue is fixed in a future software update.** Program each infusion separately instead of using the IVOT delivery mode program.

2. If an IVOT delivery mode program is inadvertently programmed and this issue occurs:
 - Immediately remove the syringe from the pump to stop the infusion, and press the Power button to turn the pump off.

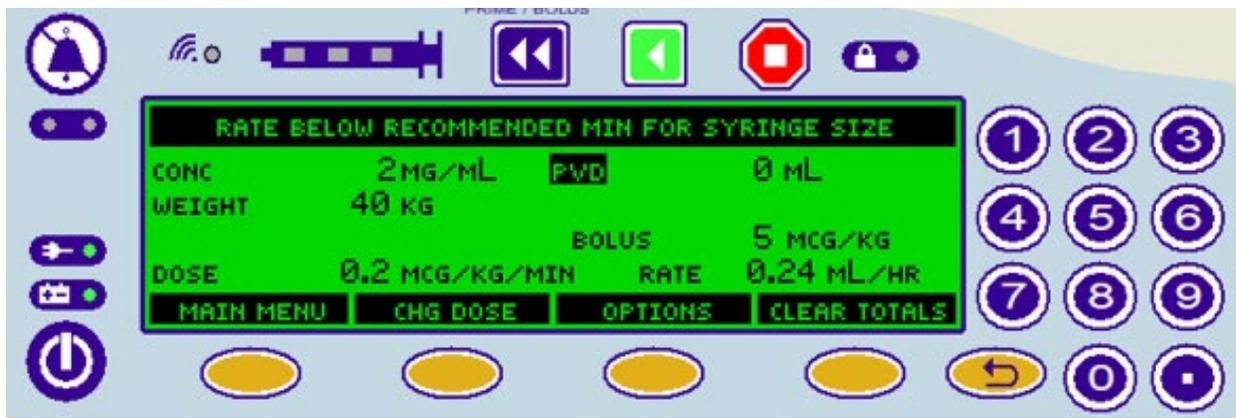
Under certain conditions, **the pump may use incorrect syringe parameters to determine if the programmed rate is below recommended minimum for the syringe size.** The pump will display a false “Rate Below Recommended Minimum for Syringe Size” alarm if this occurs, though the rate may be appropriate for the loaded syringe. The following figure (Figure 3) contains an example of this alarm screen.

When this occurs, the pump uses the Recommended Minimum Rate for the largest syringe of the same brand in the configuration for the Rate Below Recommended Minimum Rate check instead of the Recommended Minimum Rate for the syringe loaded into the pump. Although this issue does not directly impact delivery accuracy, and the pump will display the correct syringe brand and size, **this issue has the potential to affect fluid delivery since it may impact the rapid occlusion detection ability of the pump. “Pressure Increasing” alarms may occur earlier than expected or have false alarms, either with or without an occlusion present.**

Figure 3: False Rate Below Recommended Minimum for Syringe Size Alarm

The occurrence of a false “Rate Below Recommended Minimum for Syringe Size” alarm does not prevent programming or initiating an infusion but may lead to a delay in the initiation of therapy. This issue may cause “Pressure Increasing” alarms to occur earlier than expected or have false alarms, either with or without an occlusion present, which may inappropriately interrupt infusions. This may also cause therapy delays while the clinician addresses the issue and reprograms the infusion. To date, Smiths Medical has not received any reports of serious injuries or deaths related to this issue.

- If multiple syringes are needed for an infusion, program each syringe as a new infusion.**
- If you see this false “Rate Below Recommended Minimum for Syringe Size” alarm notification, do not continue the infusion: clear the infusion and re-program the infusion with the desired infusion parameters and syringe.

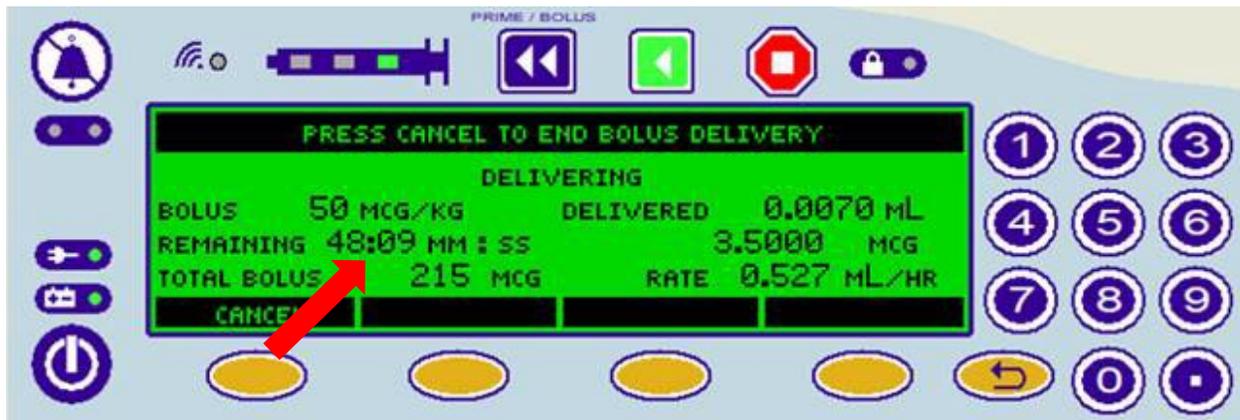
In rare situations, the pump may display an incorrect value for the time remaining during a **Bolus Dose or Loading Dose infusion** (see Figure 4). If this issue occurs, the **pump will infuse correctly to the intended infusion time even though the displayed time remaining is incorrect**. The pump appropriately transitions to continuous infusion upon completion of the Bolus Dose or Loading Dose as programmed.

Figure 4: Example of Incorrect Time Remaining. “REMAINING 48:09 MM:SS” should be displayed as “REMAINING 04:09 MM:SS”

Displaying incorrect or conflicting information to users could potentially result in the user interrupting the therapy due to confusion, which may also cause a delay in therapy. To date, Smiths Medical has not received any reports of serious injuries or deaths related to this issue.

- When programming and monitoring Bolus Dose and Loading Dose infusions, verify that the displayed time remaining on the screen is the same as the intended time.

- If the displayed time remaining is incorrect, your options include:**
 - Depending on the clinical scenario, including consideration of the patient condition and the medication, use your clinical judgement to determine if it is appropriate to continue the infusion with the incorrect remaining time displayed, while closely monitoring the Bolus or Loading Dose to verify that the infusion converts to the continuous infusion at the intended time.

- Program the intended Loading Dose or Bolus Dose as a separate intermittent infusion. When the infusion completes, program the continuous infusion.
 - Be aware that the issue will recur if the pump (or a replacement pump) is programmed with the same Bolus Dose / Loading Dose, and continuous infusion.
